Vibration Based Damage Detections of Scour in Coastal Bridges

Adel H. Elsaid and Rudolf Seracino

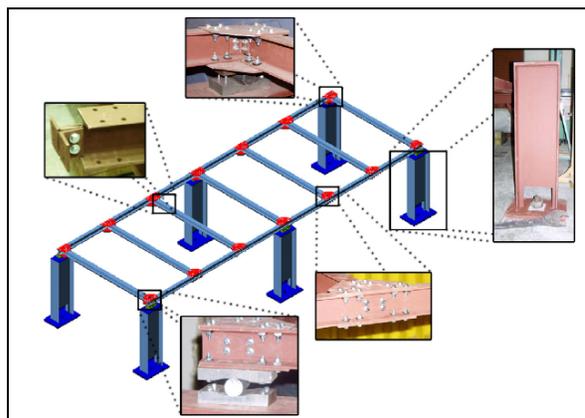
Figure 1. Schematic of the Test Specimen⁷

VBDD techniques have shown success in detecting several types of damage, such as fatigue cracking in steel beams. Since the primary objective of this research is to develop a damage detection framework capable of rapidly detecting critical damage of the superstructure as well as scour, VBDD techniques were selected to study their sensitivity for detecting scour. For this investigation, an idealized structure representing a two-span continuous bridge was selected. A schematic of the idealized structure is shown in Figure 1. This steel grid was investigated previously by Catbas and others to study the potential of two different damage-sensitive features for damage detection.⁶ A finite element (FE) model was created and verified by the experimental results of Catbas, et al. After verification of the modal analysis, the model was modified to simulate an idealized coastal bridge, where the intermediate piles were modeled. The abutments at each end were idealized with simple pin and roller supports. Six FE models were created. The first model represented the reference case and the other five models simulated five different levels of scour. Scour was modeled as an increase in the

unsupported height of the intermediate piles.

Having verified the proposed technique numerically, on-going efforts are dedicated to laboratory testing of an idealized structure (similar to that shown in Figure 1) and preparations for long-term field applications in collaboration with NCDOT Division 3 engineers. These tests will be used to evaluate the robustness of the technique allowing for the complexities, such as environmental conditions, not easily accounted for in numerical simulations.

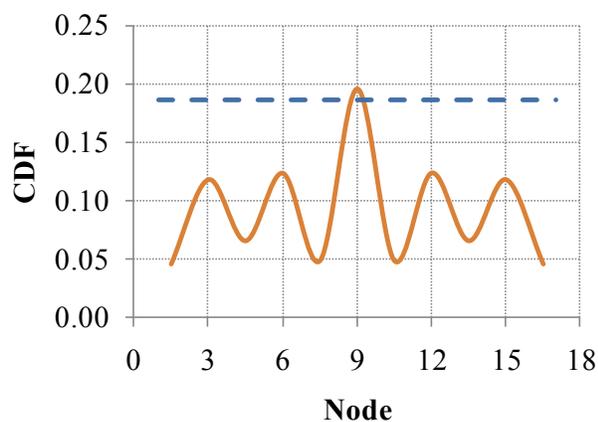
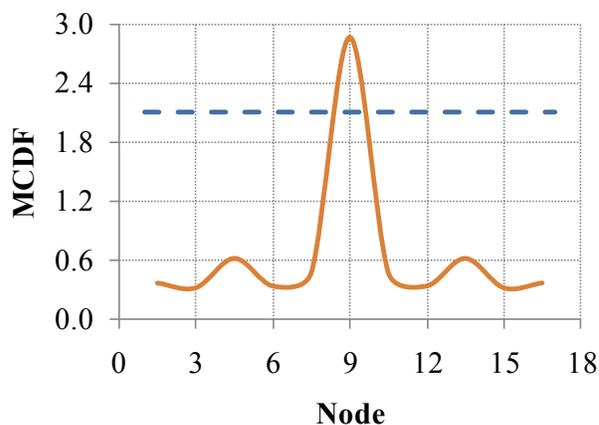
Figure 2. (a) CDF and (b) MCDF for the Idealized Structure at 40 inches of Scour.

where the MCDF calculates the average of the absolute ratio of the curvature change for a certain number of mode shapes. From Figure 2b, the MCDF clearly identified the location of scour.

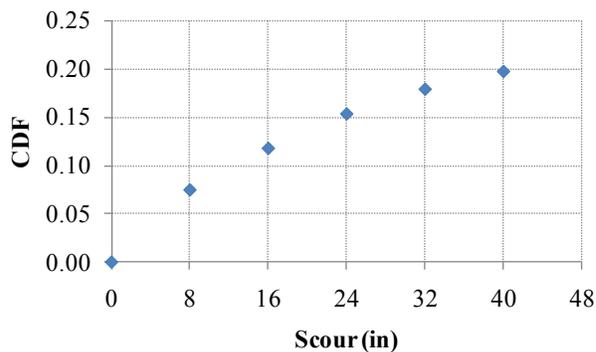
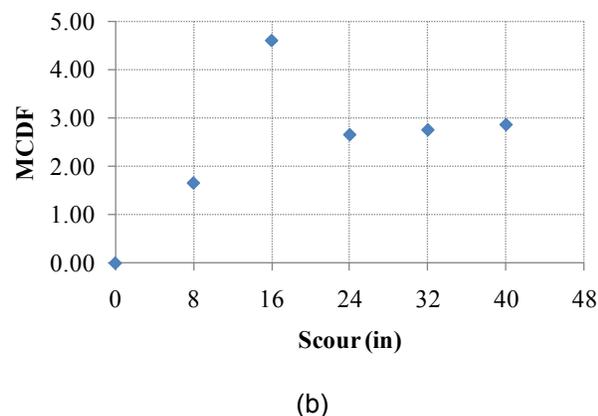
Figure 3. (a) CDF and (b) MCDF Calculated at Different Scour Levels

By calculating the CDF and MCDF for the first five horizontally displaced mode shapes it was observed that the CDF and MCDF decreases as the scour level increases as shown in Figure 3. Therefore, the CDF and MCDF may be used not only to locate scour but also to quantify the amount of scour, which would be required to quantify the remaining strength or endurance of the scour damaged structure.
